## 円孔を有する CFRP クロスプライ積層板の疲労破壊挙動

キーワード： CFRP, クロスプライ積層板, 疲労損傷進展, 非破壊検査(走査型超音波顕微鏡)

# Fatigue Fracture Behavior in CFRP Cross-ply Laminate with a Hole

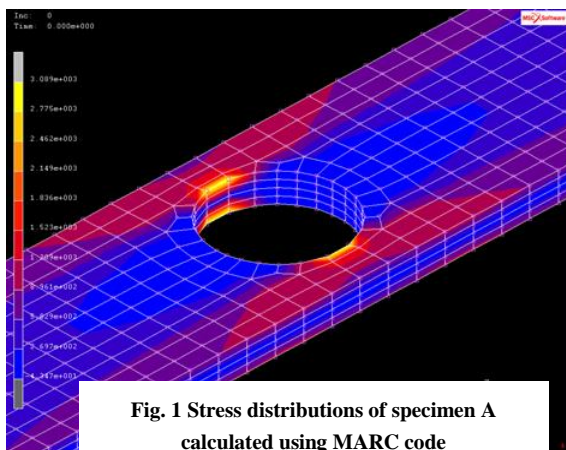
Fig. 1 Stress distributions of specimen A calculated using MARC code
