## 円孔を有する CFRP クロスプライ積層板の疲労破壊挙動

CFRP 積層板は、従来の金属材料に比べ比強度、比剛性に優れており、近年幅広い分野で、構造材料として応用されている。しかし、CFRP 積層板は面内異方性のある層を重ねて作製されるため、その疲労破壊挙動は非常に複雑な現象となる。また、積層板は構造材料として使用する際、他の部材とボルト締結されることがあるが、その際、円孔が存在することによる強度の低下が問題となる。本研究では、円孔を有する CFRP クロスプライ積層板を用いて二種類の積層構成をもつ試験片を作製し、疲労試験を行うことで、疲労破壊挙動に及ぼす負荷方向依存性を明らかにした。

# Fatigue Fracture Behavior in CFRP Cross-ply Laminate with a Hole

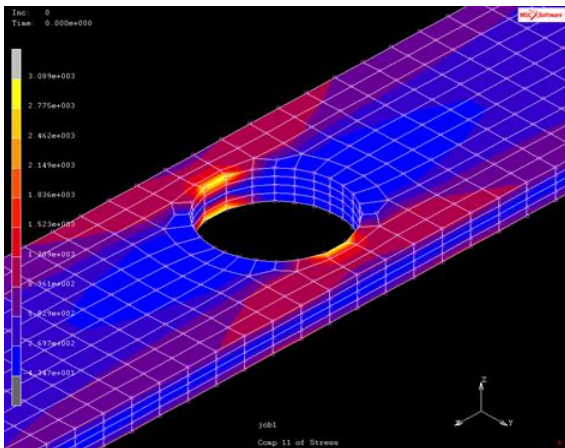
図1 荷重負荷を受ける円孔を有する CFRP 積層板内の応力解析結果

実験に先立って試験片の応力解析を行った結果が図1である。この解析結果より、円孔内部に最も応力(引張応力)が大きくなる箇所が存在することがわかった。また、他の応力成分(せん断応力)の解析では、円孔内の付加方向に対して角度を持った壁面に最大となる解析結果が得られた。実験は電気油圧式疲労試験機を用いて行った。試験片に発生する損傷はレプリカ法と、光学顕微鏡による直接観察を併用して行った。実験中、変位計を用いて測定した変位より等価ひずみを計算し、その時の応力からエネルギー散逸を計算した。また、内部損傷は非破壊検査法として、走査型超音波顕微鏡(SAM)を用いて行った。実験および観察結果をもとに、損傷の進展の様子をモデル化したものが、図2である。図中の写真はレプリカ法を用いて損傷を顕微鏡観察したものである。
